UNDERWATER BRIDGE INSPECTION REPORT

STRUCTURE NO. 60019

RED LAKE RIVER

DISTRICT 2 - POLK COUNTY, CITY OF EAST GRAND FORKS

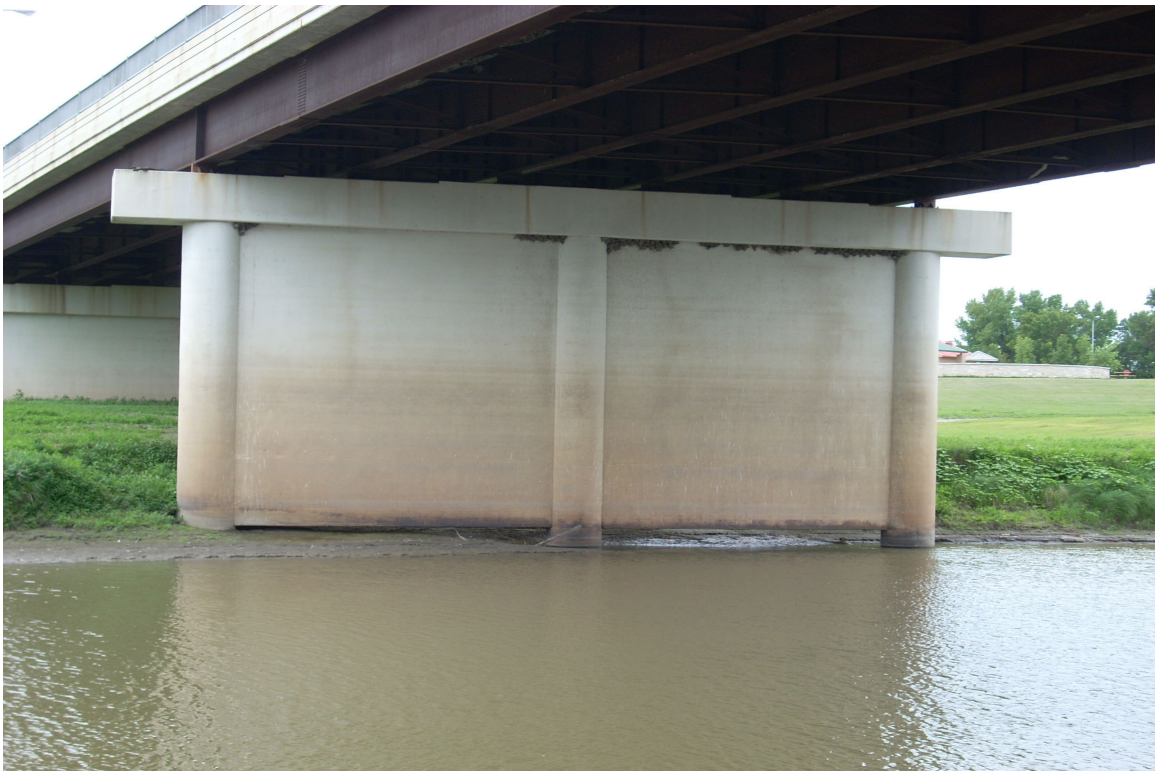
Photograph 2. Overall View of Pier 6, Looking Southwest.

- 1 Overall, the concrete of the piers was found to be smooth and sound with no significant deterioration.
- 2 A light accumulation of timber debris, consisting of 8 to 10 inch diameter branches, was observed at the upstream sides of downstream column of Pier 6 from the channel bottom to the waterline and radiating southward.

- (A) Monitor the accumulations of timber debris around Pier 7 and the undermining present at the pier during future underwater inspections.
- (B) Reinspect the submerged substructure units at the normal maximum recommended (NBIS) interval of five (5) years.

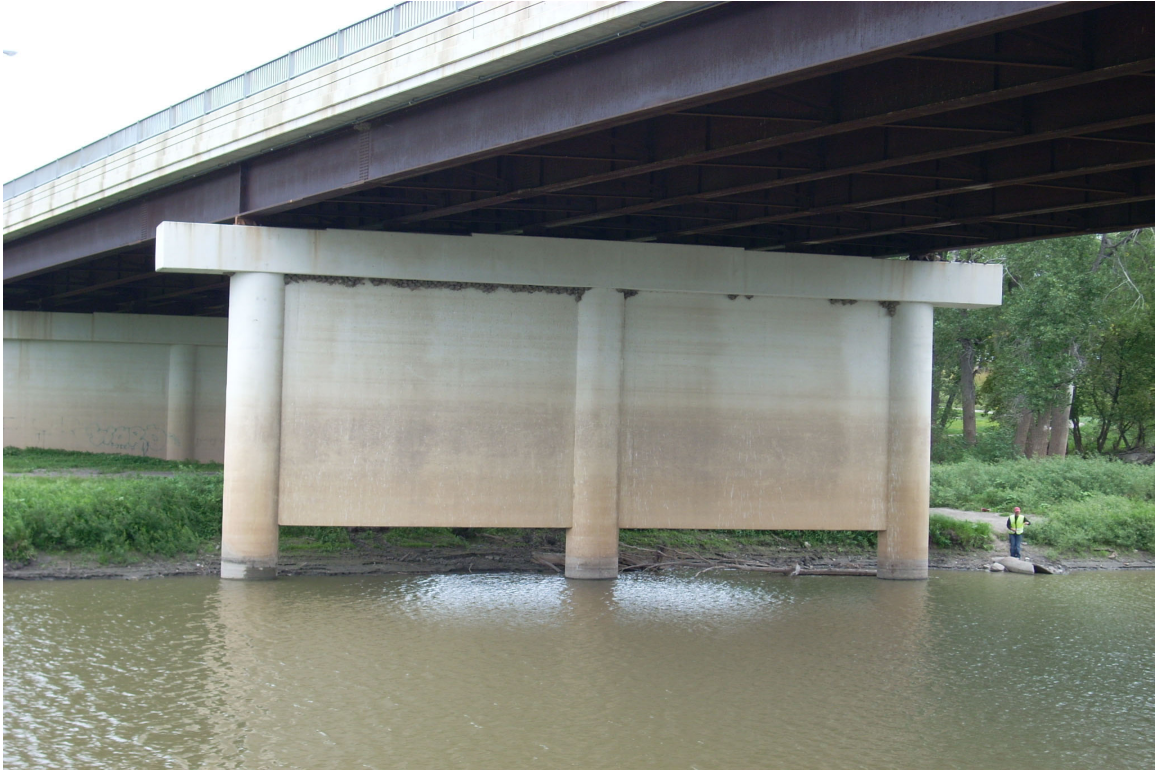
Photograph 3. Overall View of Pier 7, Looking Northeast.

- 3 The top of the footing of the upstream column of Pier 7 was exposed around the entire column at 3.1 below the waterline feet with a maximum vertical face exposure of 4 feet (full height). The footing was undermined at the southwest corner, 3 feet along the south face, 1 foot along the west face, with 6 inches of height and 1.5 feet of maximum penetration.

- 4 A moderate accumulation of timber debris, consisting of 6 inches to 1 foot diameter logs and branches, was observed around the upstream end of Pier 7 and extended from the channel bottom to approximately 2 feet above the waterline. The timber debris was located from the pier to the north shore and from the upstream column to the center column of Pier 7. There was also some light drift around the remainder of the pier.

- 5 The top of footing of the center column of Pier 7 was exposed along the south face for 8 feet and east face for 2 feet with up to 3.5 feet of vertical exposure.

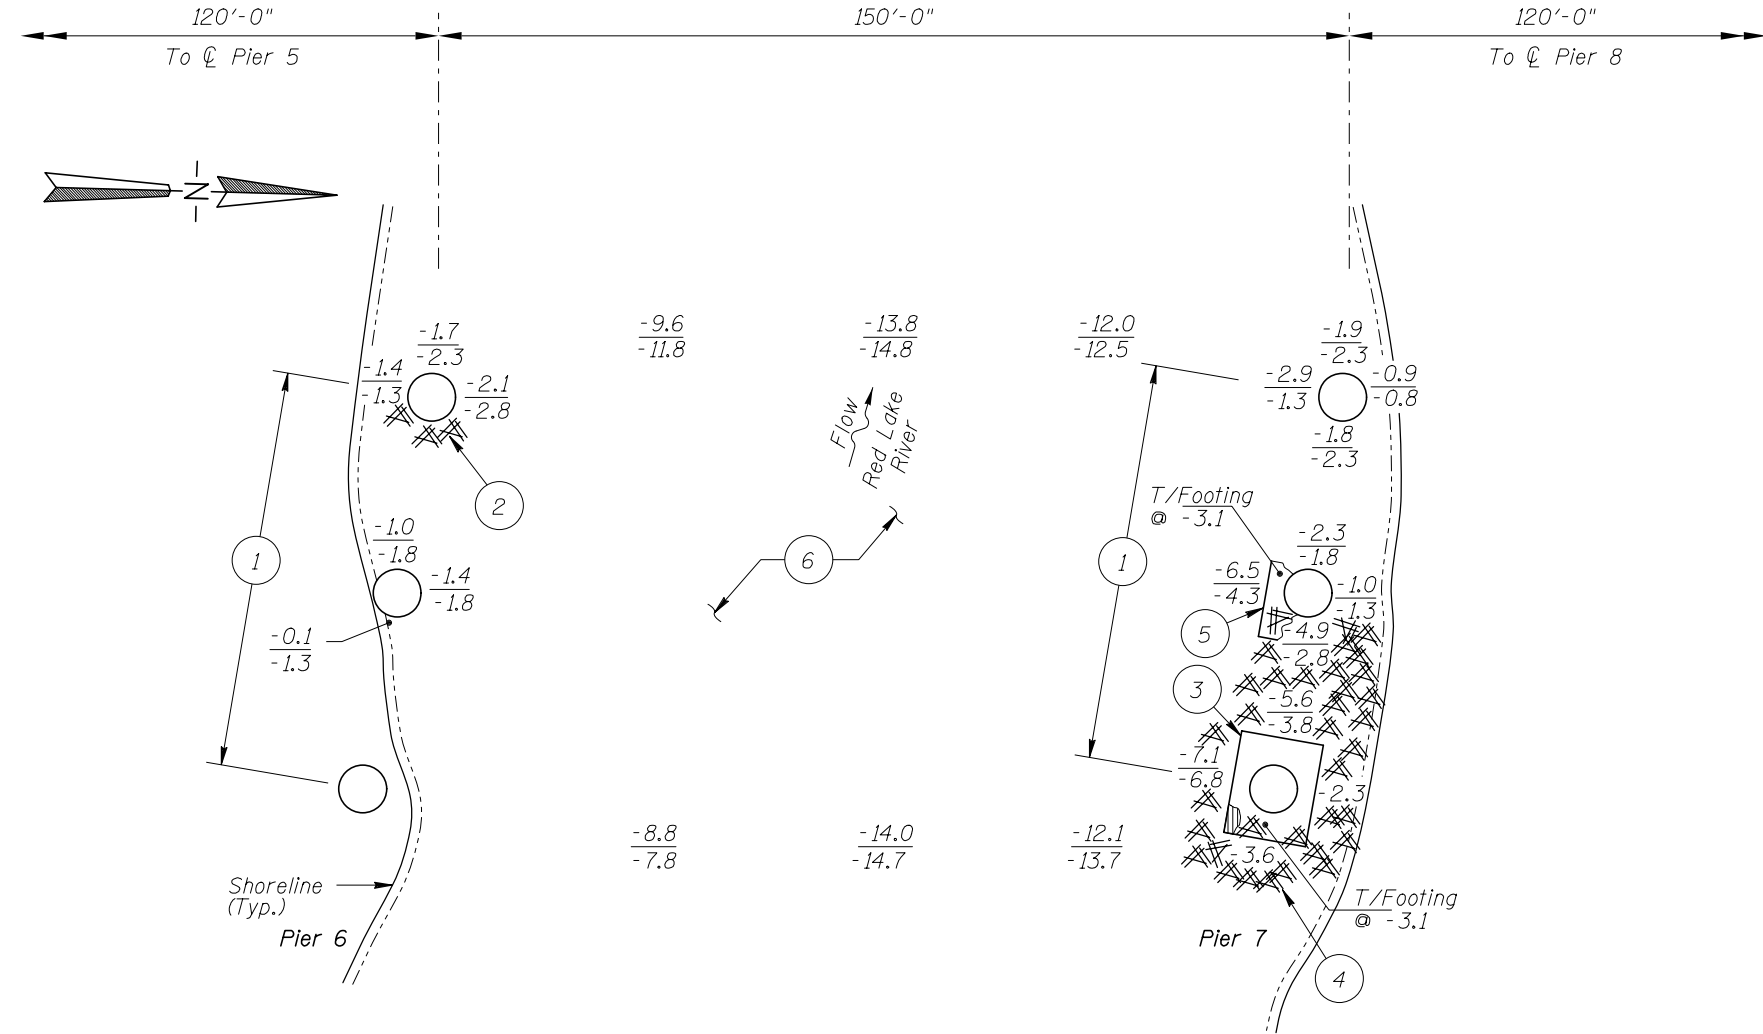
SOUNDING PLAN

- 6 The channel bottom consisted of clay with up to 1 foot of probe rod penetration around both piers.
